TITLE: Oxygen System Hazards Analyses

PRINCIPAL INVESTIGATOR: Joel M. Stoltzfus, Ph.D.

REPORT DATE: 26 Sep 95

TYPE OF REPORT: Final

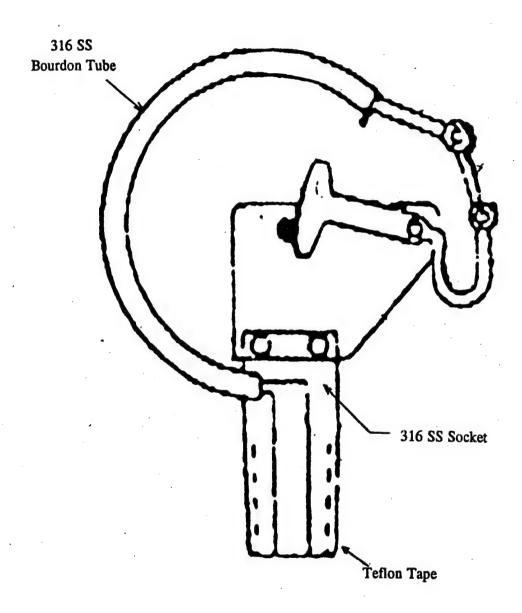
Figure 4
Pressure Gauges 42, 45, and 118

The schematic of pressure gages 42, 45, and 118 is shown in Figure 4. Both the Bourdon tube and socket are made of 316 stainless steel (SS) and the pipe threads are wrapped with Teflon® tape. The worst-case operating temperature and pressure for these gages are 120 °F (49 °C) and 2,250 psig (15.5 MPa), respectively.

NOTES: Adiabatic compression is a remotely possible ignition hazard. The worst-case scenario is when a vented line is rapidly pressurized to a gage. For example, opening Manual Valve 1 (29A) or 2 (29A) may rapidly pressurize gage 42. Also, only gage 45 has a Snubber fitting to protect it from pressure surges and shocks. However, adiabatic compression is only a remotely possible ignition source because MV1 and 2 are slow-opening valves and, thus, guard against rapid pressurization. The Teflon® tape on these pressure gages should be installed with good practice; that is, no tape should cover the last two threads. If these gages are contaminated with hydrocarbon oil upon installation or cleaned with a flammable cleaning solvent, then the ignition hazard by pneumatic impact increases to possible, or even probable. Ensure that procurement, assembly, and operational documentation include warnings that oxygen assembly or disassembly must be done properly, cleanliness must be maintained, only clean components, parts, and tools must be used, and flammable solvents must not be used to clean parts.

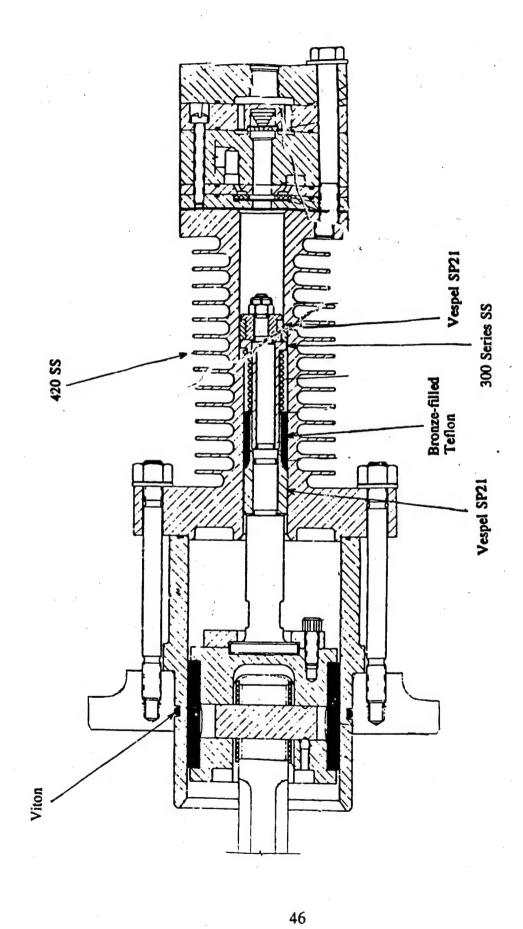
Figure 5b Mid-Pressure Cylinder of Oxygen Compressor

The schematic of the mid-pressure cylinder is shown in Figure 5b. Like the low-pressure cylinder, the body is 300- and 400-series SS with a 300-series SS piston and a 420 SS cylinder. Inside the cylinder are bronze-filled Teflon® seals and a Vespel® SP-21 follower. Worst-case operating conditions include a maximum temperature of 300 °F (150 °C) at the upper head and a maximum pressure of 1,100 psig (7.6 MPa) in the head chamber, with a discharge pressure of 2,250 psig (15.5 MPa).

NOTES: Frictional heating is a possible ignition hazard in the mid-pressure cylinder as heat may be generated along the sidewall from the stroke of the piston. As in the low-pressure cylinder, polymers rub against stainless steel throughout the stroke, but the coefficient of friction is too low for ignition to occur. In addition, stainless steel is not flammable in this setting due to its large bulk (the thickness is greater than 2.5 in. (0.64 cm). In the event of some polymer failure, metal rubbing on metal could cause galling between the 420 SS (hardened) cylinder and the 300-series (nonhardened) piston parts. The piston parts, being the softer material, will gall if friction occurs, possibly producing enough heat for ignition. Therefore, the flammability is controlled by the softer piston parts.

Adiabatic compression is an almost impossible ignition hazard. Rapidly compressing the oxygen gas inside the cylinder creates a pressure ratio of two to one, generating a maximum temperature which is much less than the AIT (ASTM G 63).

Particle impact is also an almost impossible source of ignition as the gas velocities are too low to create an impact hazard.

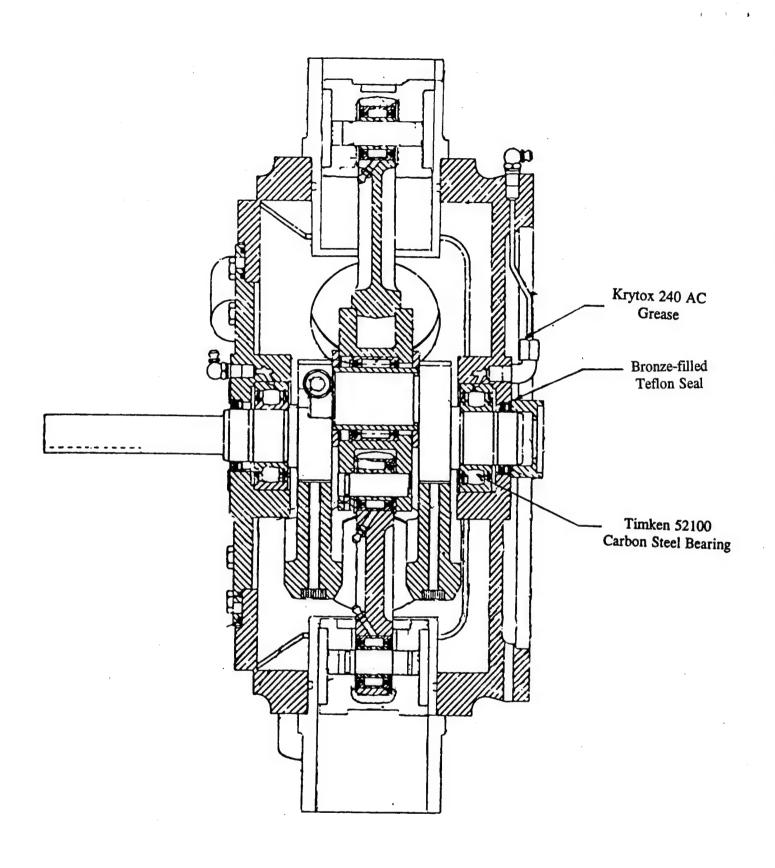
Figure 5d
Frame and Running Gear of Oxygen Compressor

The schematic of the frame and running gear of the oxygen compressor assembly is shown in Figure 5d. The body of the frame is stainless steel with bronze-filled Teflon® seals, Timken 52100 carbon steel rolling element bearings, and Krytox® 240 AC lubricant throughout. The worst-case operating temperature is ambient temperature. The worst-case operating pressure is 25 psig (0.17 MPa) with the failure of a piston seal. Otherwise, 2.0 psig (0.01 MPa) is the normal operating pressure.

NOTES: The metals in this component are nonflammable under normal conditions because the gas pressure is low. However, the metals are considered flammable if a single failure occurs as the oxygen pressure in the frame housing would increase significantly.

Frictional heating is only a remotely possible ignition hazard in the frame and running gear. Two failures are required for a frictional heating ignition hazard to exist. If the roller bearings failed, then another failure must exist, which would increase the oxygen pressure enough to make the metals flammable.

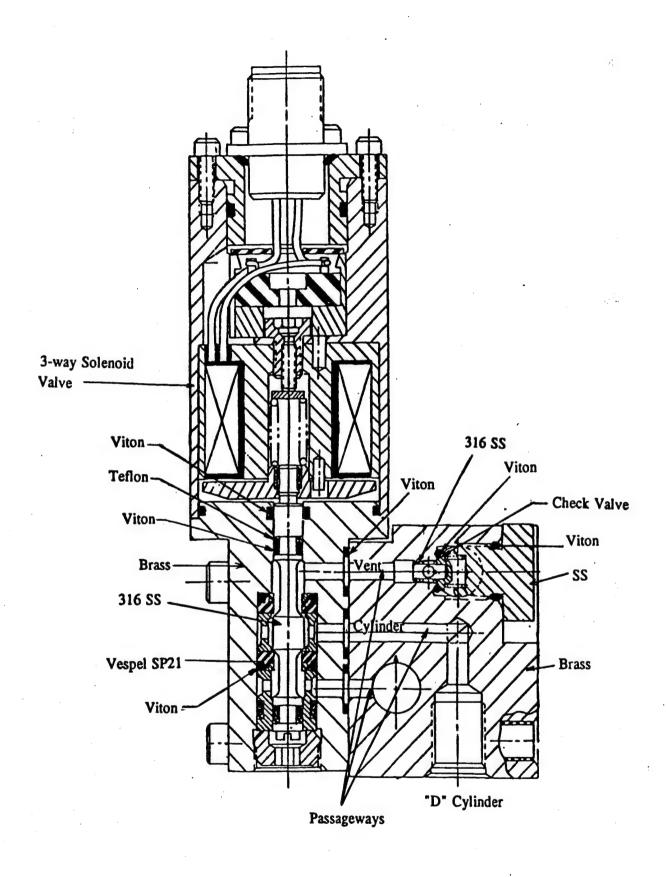
Figure 6
Manifold Valve Assembly 124

Figure 6 shows the check valve as part of the manifold valve assembly. The body is brass, the poppet is 316 SS, and the valve seat is Viton[®]. The valve also has a Viton[®] O-ring seal. Worst-case operating conditions include ambient temperature and a pressure of 2,250 psig (15.5 MPa). Also, the largest change in pressure is maximum pressure to ambient.

NOTES: Adiabatic compression is an almost impossible ignition hazard. No operational mechanism exists to get rapid compression on the valve. During the fill cycle, pressure is balanced to less than 200 psi (1.4 MPa) by computer control.

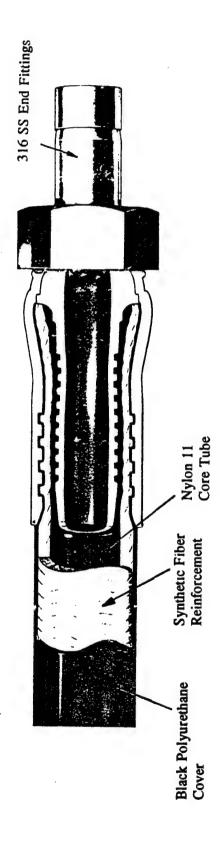
Figure 23
High/Low Pressure Flexhoses

The schematic for the high-pressure hoses is shown in Figure 23. The end fittings are made of 316 SS, the core tube is Nylon II and polyurethane. The worst-case operating conditions are 120 °F (49 °C) and 2,250 psig (15.5 MPa).

The schematic for the low-pressure hoses is shown in Figure 23. The configuration and materials in these hoses are the same as in the high-pressure hoses. The worst-case operating conditions are 120 °F (49 °C) and 70 psig (0.48 MPa).

The configuration and materials in this hose are identical to the low-pressure hose, Figure 23. The worst-case operating conditions are 120 °F (49 °C) and 2,250 psig (15.5 MPa), respectively.

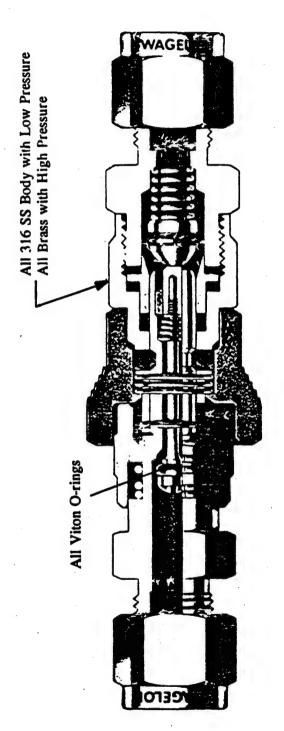
Figure 24 Quick Disconnect

The schematic for the quick disconnect is shown in Figure 24. For the high-pressure hoses, the body is currently made of stainless steel, but a decision has been made to change to plated brass. Therefore, this analysis will be for brass. All O-rings are Viton[®]. The worst-case operating conditions include ambient temperature and a pressure of 2,250 psig (15.5 MPa).

The schematic for these quick disconnects is shown in Figure 24. The configuration for the low-pressure quick disconnects is the same as for the high-pressure quick disconnects except the body is 316 SS instead of brass. The worst-case operating temperature and pressure are 120 °F (49 °C) and 70 psig (0.48 MPa), respectively.

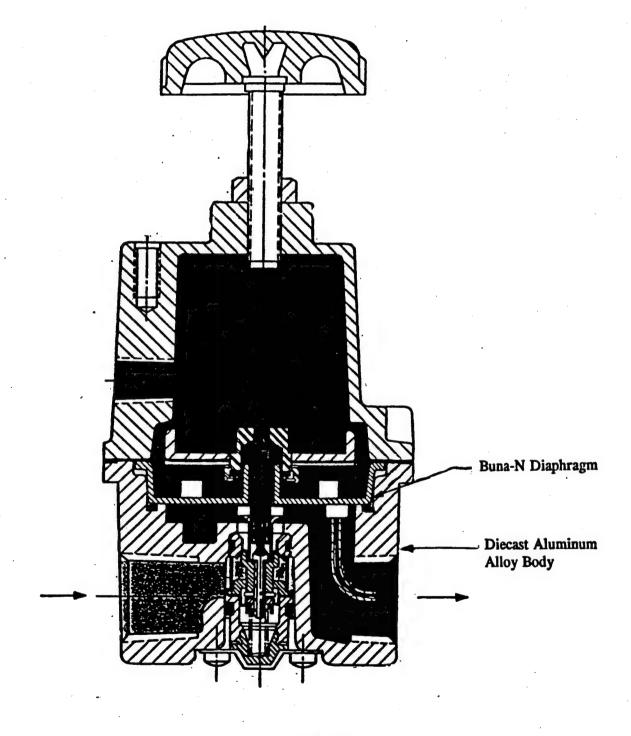
Figure 25
High Flow Regulator 52AA

Both of these regulators contain materials that are completely inappropriate for use in oxygen systems. No analysis was attempted on these components. Recommendation is to immediately replace both regulators with oxygen-compatible components.

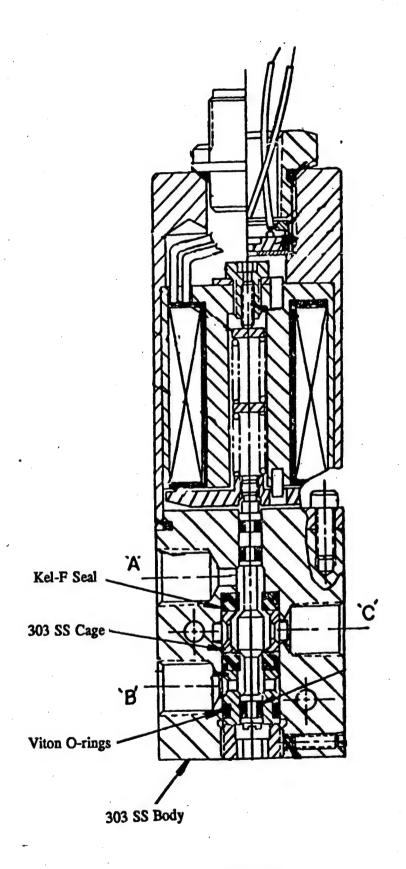
Figure 27
Back-up Oxygen Valve 37

The schematic of the backup oxygen valve is shown in Figure 27. The valve has a 303 SS body, Viton[®] O-rings, and a Kel-F[®] 81 seal. The worst-case operating temperature and pressure are 120 °F (49 °C) and 70 psig (0.48 MPa) from both ports of the valve.

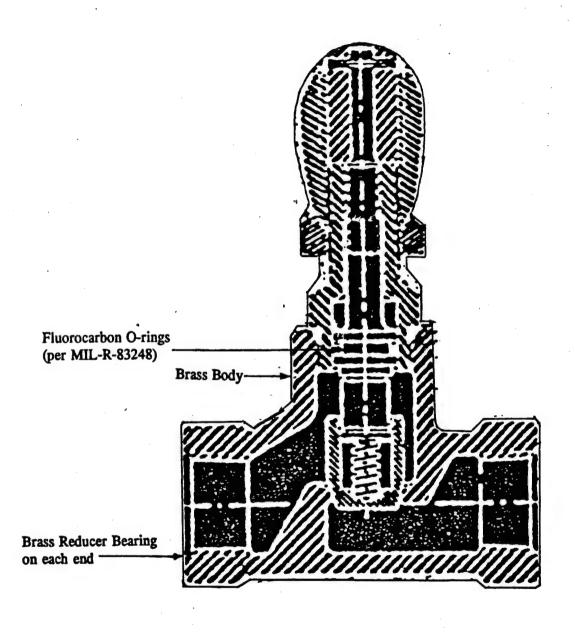
Figure 28 Constant Purge Valve 25

The schematic of the constant purge valve is shown in Figure 28. This valve currently has a stainless steel housing, but this will change to brass. Analysis is performed as if component is brass. The O-rings are fluorocarbon (per MIL-R-83248) and each port contains a brass reducer bearing. The worst-case operating conditions are 120 °F (48 °C) and 35 psig (0.24 MPa).

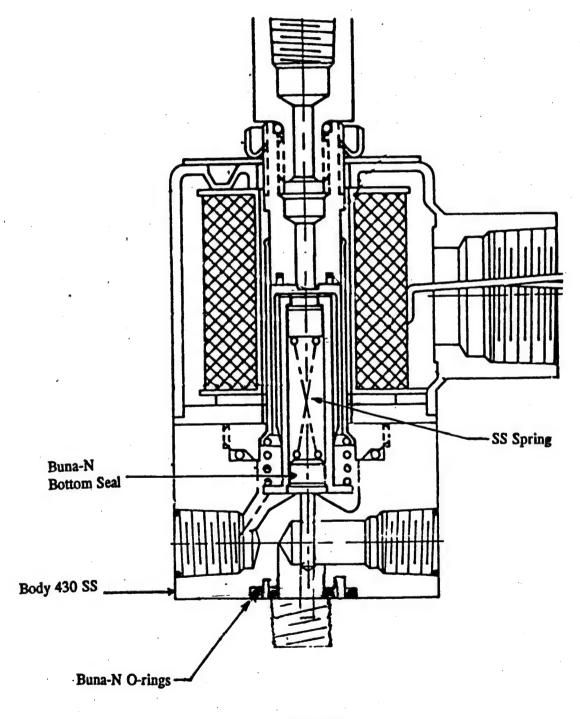
Figure 29 Purge Control Valve 24

The schematic for the purge control valve is shown in Figure 29. The valve body is passivated 430 SS with a Buna-N[®] bottom seal and Buna-N[®] O-rings. Worst-case operating conditions include a temperature of 120 °F (48 °C) and a pressure of 35 psig (0.24 MPa).

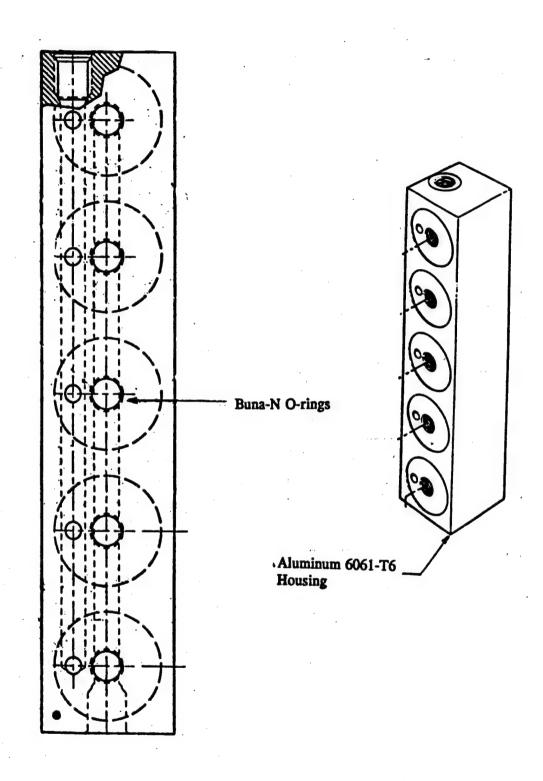
Figure 30
Purge Control Valve Manifold

The schematic of the purge control valve manifold is shown in Figure 30. It has an aluminum housing and Buna-N[®] O-rings. Worst-case operating conditions include a temperature of 120 °F (48 °C) and a pressure of 35 psig (0.24 MPa).

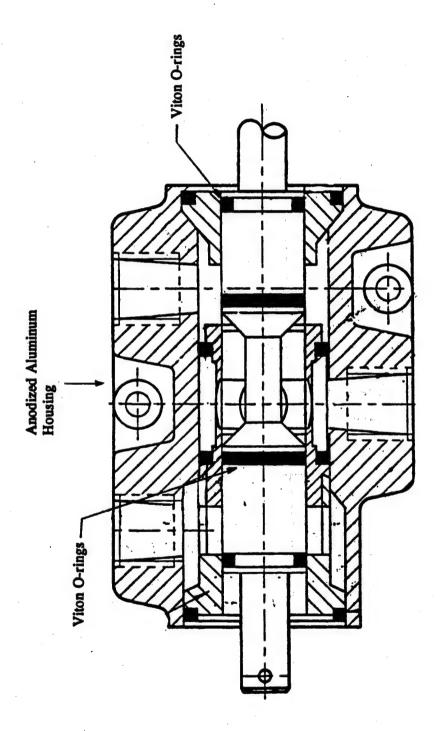
Figure 31
Equalization Valve 23

The schematic of the equalization valve is shown in Figure 31. The materials consist of an anodized aluminum housing and Viton[®] O-rings. The worst-case operating conditions for this valve include a temperature of 120 °F (49 °C) and a pressure of 35 psig (0.24 MPa).

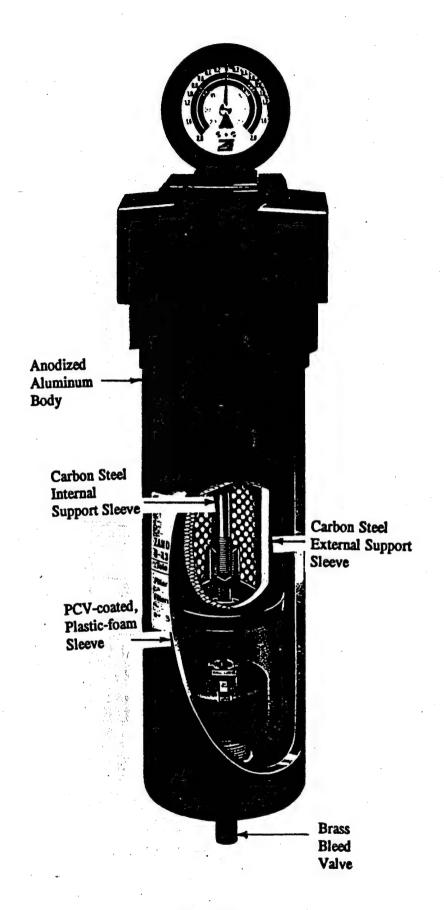
Figure 32 Product Filters 43 and 101

The schematic of product filters 101 and 43 is shown in Figure 32. The body is anodized aluminum; the internal and external support sleeves are carbon steel; the filter material is borosilicate glass fiber. The element filtration rating is 0.01 micron with 99.9999 percent efficiency. The worst-case operating conditions are 120 °F (49 °C) and 77 psig (0.53 MPa).

The schematic for the bleed valves of these two filters is also shown in Figure 32. The bleed valves are made of brass and are exposed to the same operating conditions as the filter itself (120 °F (49 °C) and 77 psig (0.53 MPa)). The maximum flow rate through the bleed valve is 200 ft³/h (6 m³/h).

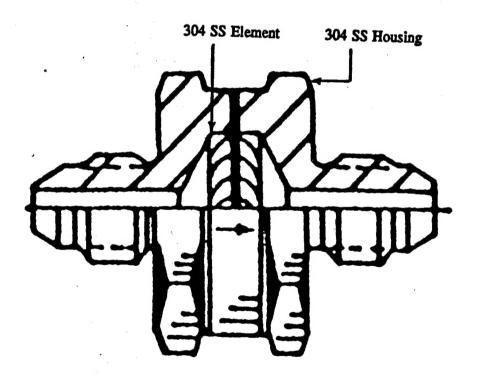
Figure 34 Oxygen Filter 132

The schematic of the oxygen filter is given in Figure 34. The filter is 304 SS throughout. The worst-case operating conditions include a temperature of 120 °F (49 °C) and pressure of 2250 psig (15.5 MPa).

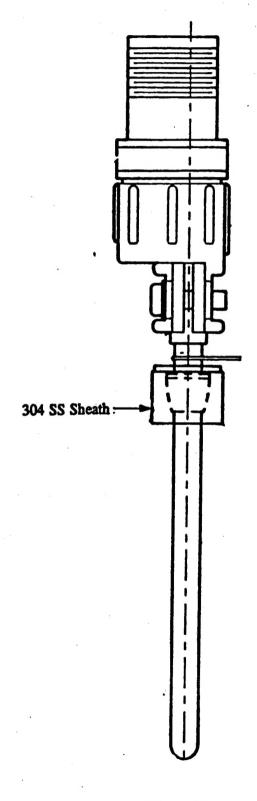
Figure 35
Temperature Indicators 112, 112B through 112F

The schematic of the temperature indicators is shown in Figure 35. The sheath material is 304 SS. The worst-case operating conditions include a temperature of 300 °F (150 °C) and a pressure of 2,250 psig (15.5 MPa).
